# An Investigation Into the Use of Polymer-Concrete for Rapid Repair of Airfield Pavements

AIR FORCE INSTITUTE OF TECHNOLOGY  
WRIGHT-PATTERSON AFB, OH 45433

JANUARY 1978

FINAL REPORT FOR PERIOD JUNE 1977-DECEMBER 1977

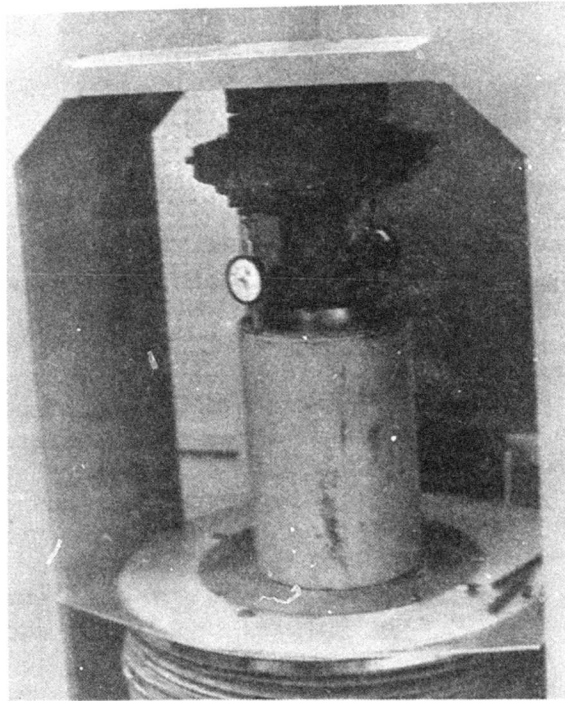
Figure 1. Compression Strength of Modulus of Elasticity Tests

The test for modulus of elasticity was ASTM C469-65: "Static Modulus of Elasticity of Concrete in Compression". This test was the same as the compressive strength test except that a

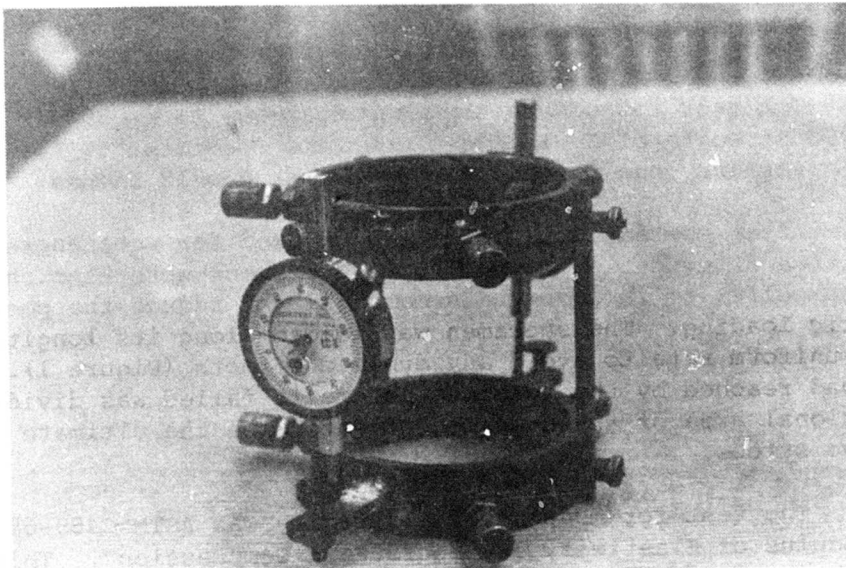
Figure 2. Compressometer

compressometer was fastened to the cylinder to read the compression of the specimen under load (Figure 2). The compressometer had two dial gages, on opposite sides of the cylinder, to read the vertical deformations of the specimen in gage lengths of 4 or 10 inches (Figure 3). The average gage reading was divided by the gage length to obtain the strain of the specimen in inches/inch. The compressive stress was plotted versus the strain to obtain the modulus of elasticity, using the secant modulus of the strain at 50 percent of the ultimate compressive strength.

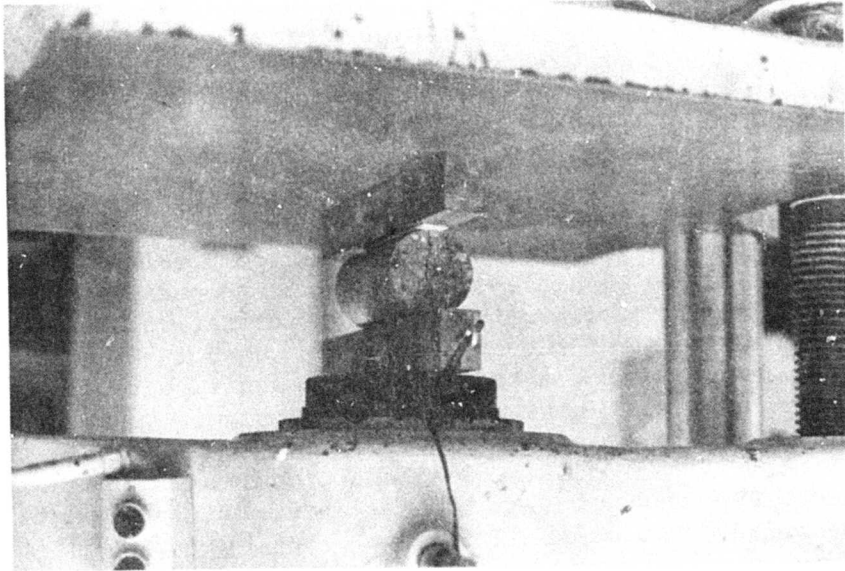
Figure 3. Splitting Tensile Strength Test

The test for splitting tensile strength was ASTM C496-71: "Splitting Tensile Strength of Cylindrical Concrete Specimens". The specimens were 3 x 6 inch cylinders. A strip of 1 inch wide by 1/8 inch thick plywood was placed longitudinally along the top and along the bottom of the cylindrical specimen. The specimen was carefully placed on its side such that the loading frame was centered directly above the center of the cylinder. The load was applied at a uniform rate until failure. The highest load was then used to compute the splitting tensile stress in the specimen according to the formula:

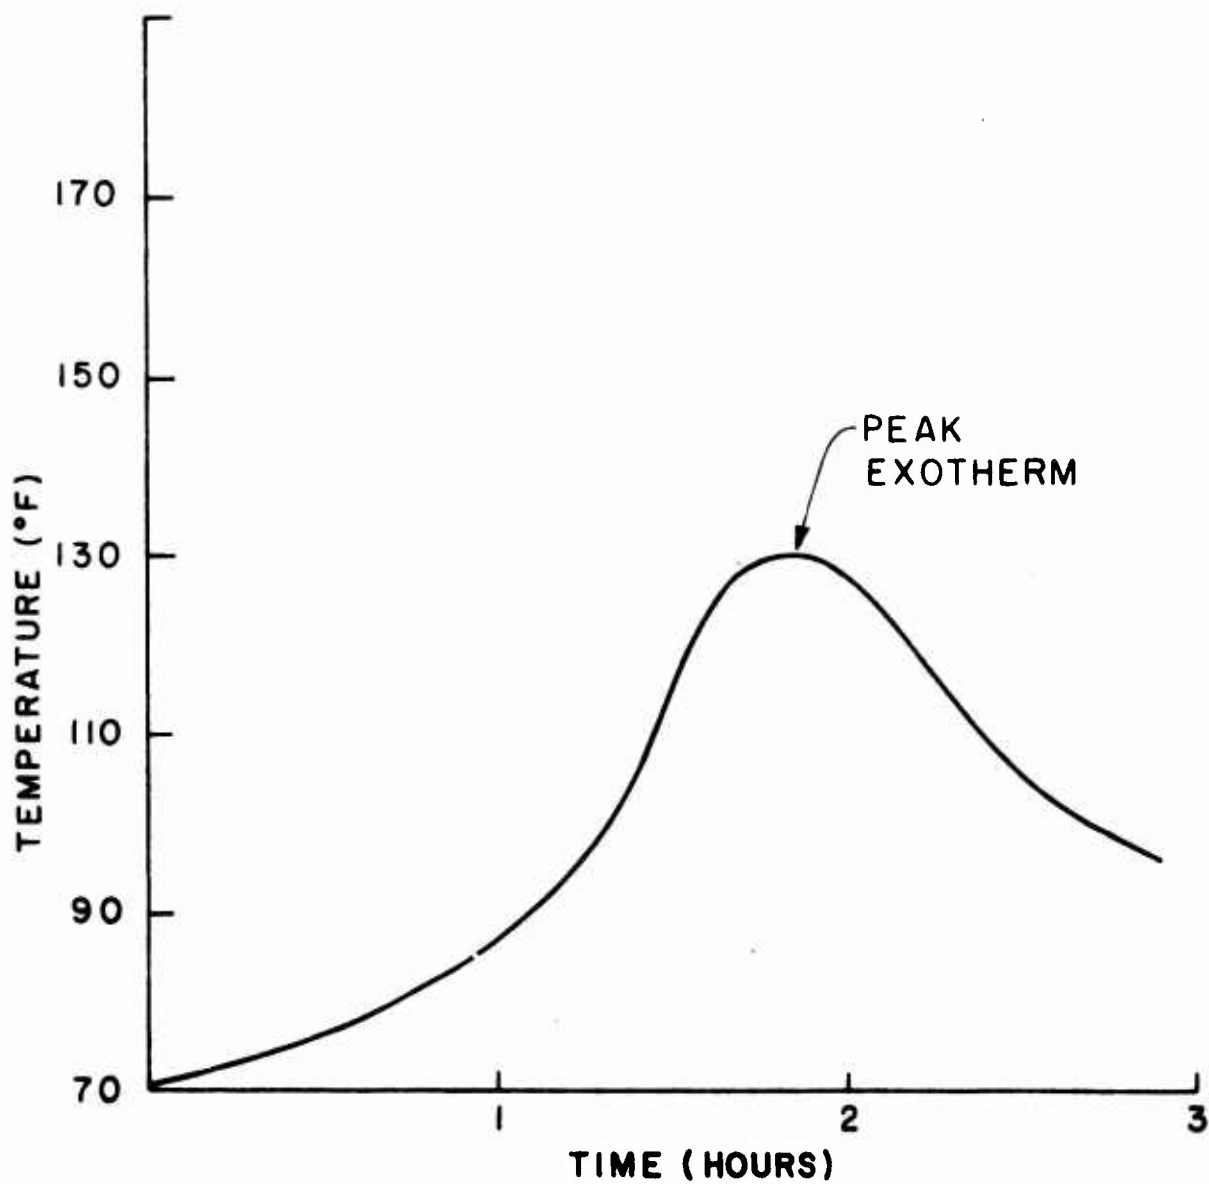
Figure 5. Typical Time Temperature Curve for PC

A laboratory test was made to verify the effects of ambient temperature on set time. The experiment consisted of placing the monomer and aggregate in an environmental chamber where the ambient temperature could be regulated. After the monomer and aggregate had reached the temperature of the chamber, the monomer components were mixed in the environmental chamber. Standard concrete test cylinders, 3 x 6 inches, were prepared in the chamber. In each case, special care was taken to insure that the gradation and moisture content of the aggregate was kept constant. Care was also taken to prepare the cylinders in a standard manner and in general conformance with ASTM C192-69: "Making and Curing Concrete Test Specimens in the Laboratory." In preparing the cylinders, the mixed monomer was used to wet the aggregate so that it could be placed into the cylinders without segregating. A thermocouple was inserted into the polymer-concrete cylinder to monitor the temperature.

The results of the tests showed conclusively, for all formulations, that the higher the ambient temperature the less time was required to reach the peak temperature. Conversely, the lower the ambient temperature, the longer the set time.

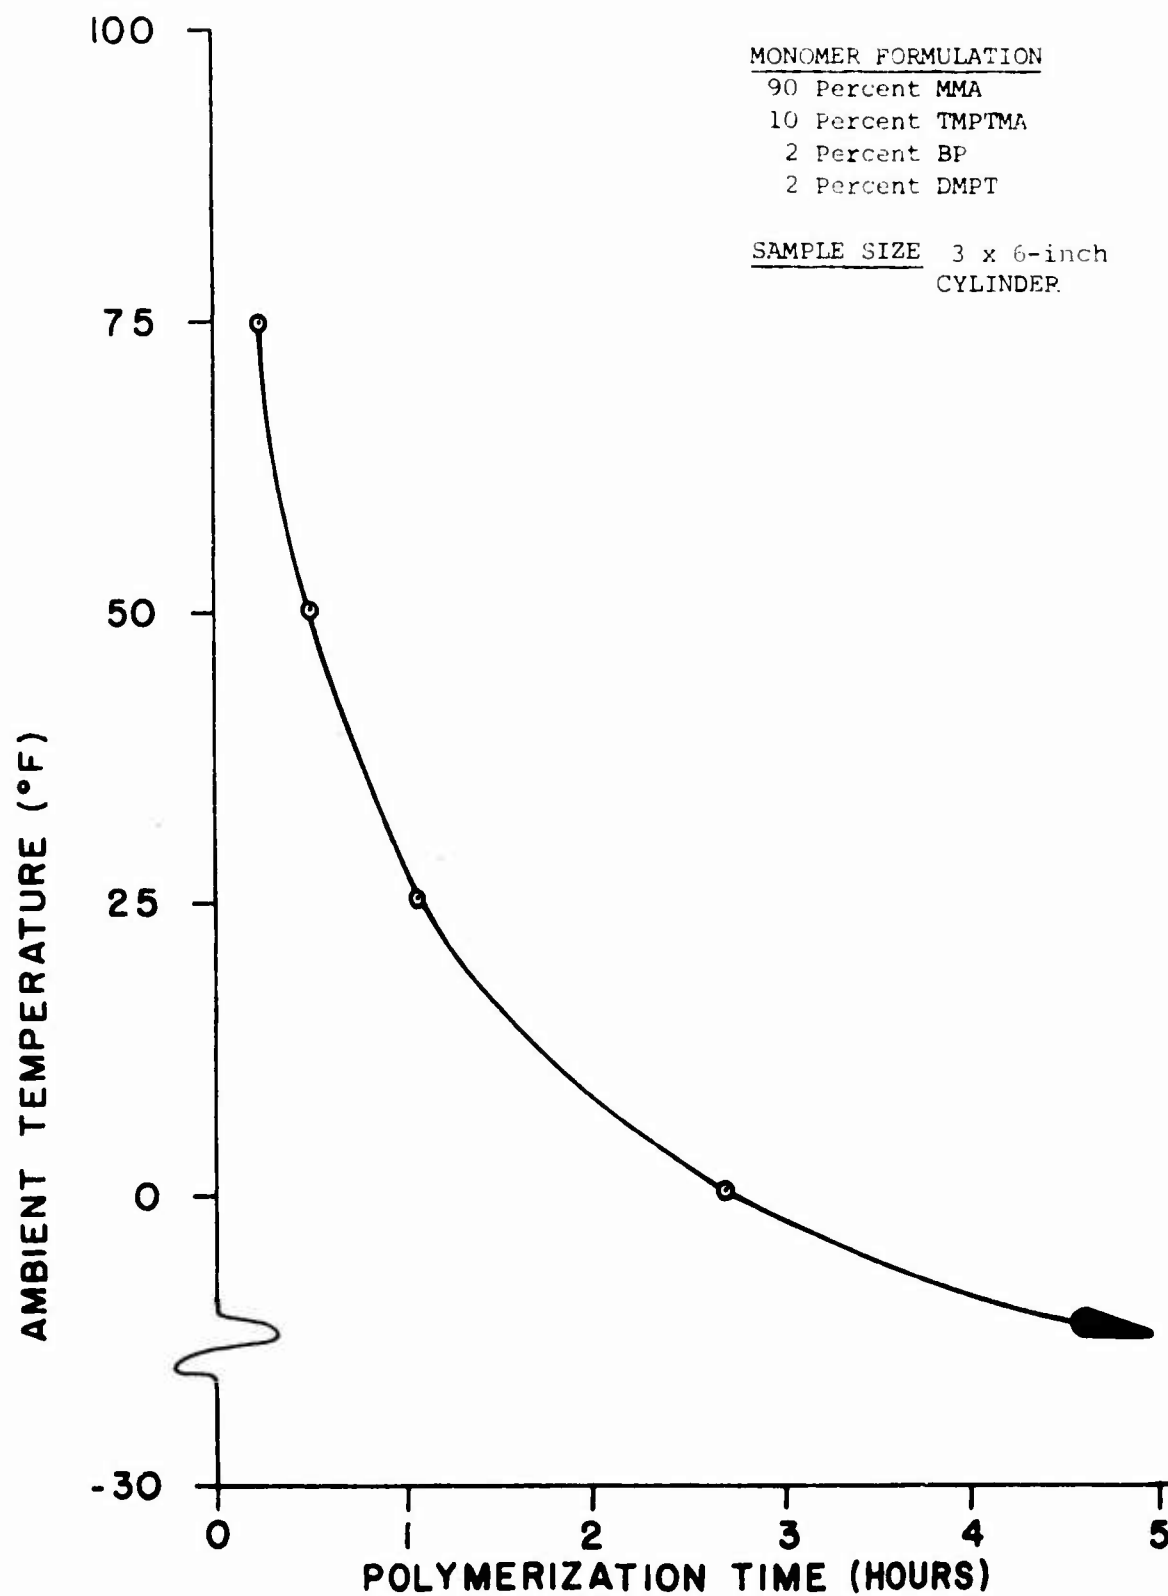
Figure 6. Effects of Ambient Temperature on Polymerization Time

The tests also showed that the effect of ambient temperature on set time is exponential. Figure 6 shows that a formulation takes only 14 minutes to set at 75°F. If the ambient temperature is reduced to 50°F the set time is doubled to 28 minutes. If the ambient temperature is reduced to 25°F, the set time is more than doubled again to 65 minutes. This formulation was successfully polymerized at -30°F but the set time was approximately 10 hours.

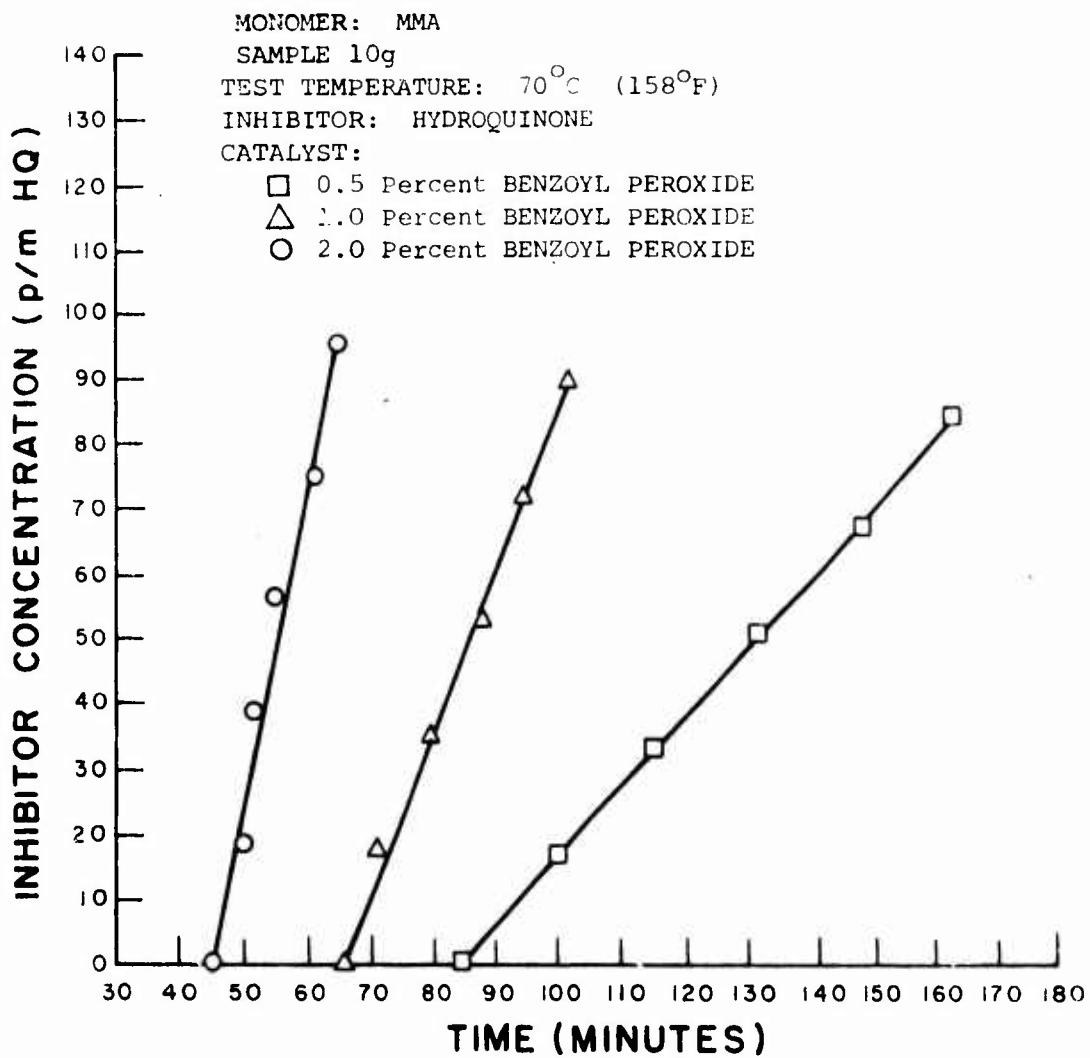
Figure 8. Effect of Inhibitor Concentration on Polymerization Time

inhibitor the longer the shelf life. Inhibitor can also be added periodically to increase the shelf life. Figure 8 is a calibration curve used to determine the amount of inhibitor present in a sample of MMA (Reference 2). It also shows the effect of inhibitor concentration on polymerization time, measured by the peak exotherm method.

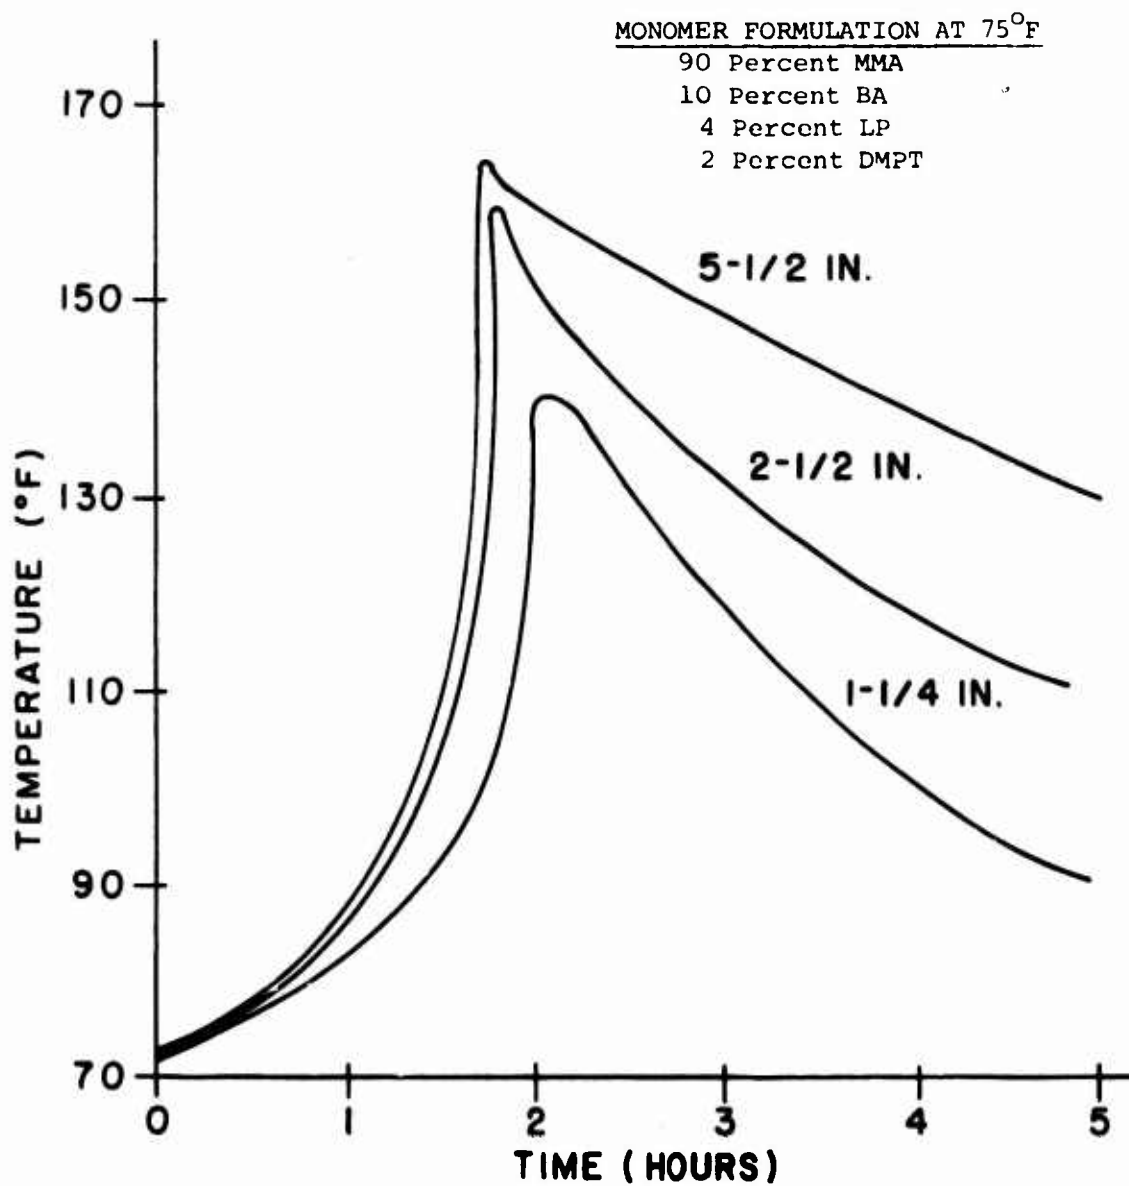
Figure 9. Effects of Repair Depth on Polymerization Time

The size of the polymer-concrete sample that is being polymerized affects the polymerization rate. A test was developed to determine the effects of varying depth on polymerization rate. Wooden box forms were constructed, 10-1/2 by 10-1/2 inches and 5-1/2 inches high. A monomer formulation that has been used in the field to repair highways was selected (90 percent MMA, 10 percent BA, 4 percent LP and 2 percent DMPT). The only variable was the depth of the polymer-concrete repair which was varied from 1-1/4 inches to 5-1/4 inches. Other variables such as ambient temperature, aggregate, and monomer formulation were all kept constant. The polymer-concrete was mixed and placed in the forms, and a thermocouple was inserted to record the temperature with respect to time. The results in Figure 9 show polymerization rate increased with the increasing depth.

One additional discovery was that a 3-3/4 inch depth specimen in which the monomer partially leaked from the forms was slower to polymerize than the others. Excessive leaking of the monomer in some of the field tests which required additional monomer also tended to slow the polymerization rate. From field tests of polymer-concrete repairs as large as 2 cubic yards it seems that very large PC repairs can be made successfully.

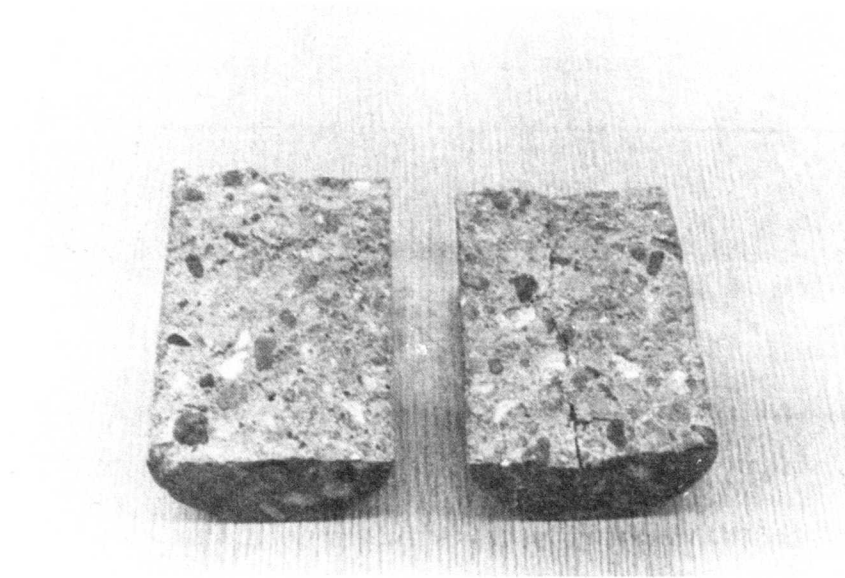
Figure 14. Failure Plane of PC Cylinder

Just as portland cement concrete depends largely on the strength of the aggregate for the strength and modulus of elasticity so does polymer-concrete. Polymer-concrete can be made from dense, lightweight, and normal aggregates just like portland cement concrete. The stronger the aggregate the stronger the PC. In most cases, the failure plane in PC tends to pass through the large aggregate (Figure 13). In tensile tests, it is common to see the failure plane pass through more than half of the large aggregate (Figures 14 and 15).

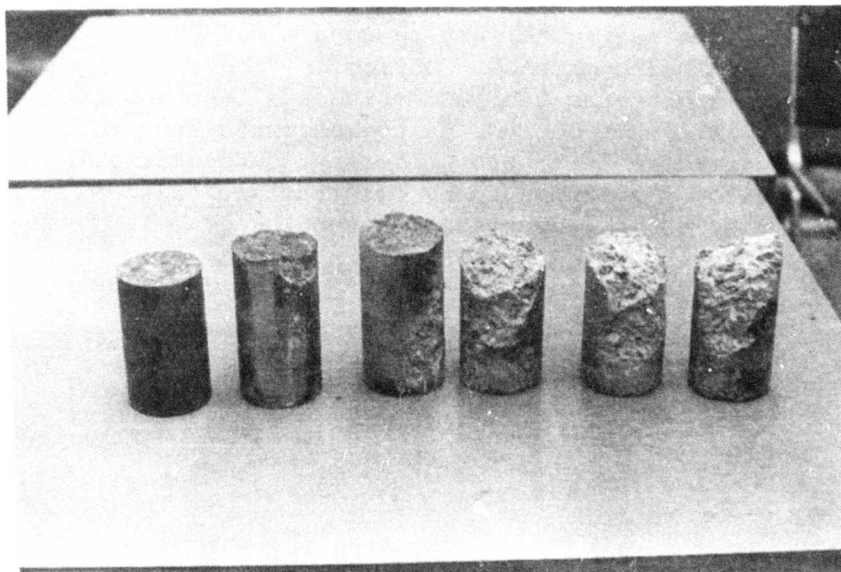
Figure 16. Specimens at 1.64 Percent Moisture Content

A test was developed to measure the effect of moisture content of sand on compressive strength and tensile strength. Aggregate consisting of 50 percent pea gravel (3/8-inch) and 50 percent oven-dried concrete sand was selected (Table 9). Water was added to the sand in three different amounts and stirred by hand until uniform color was achieved. Two samples of each sand were taken and weighed, oven-dried and reweighed to determine moisture content. Six PC cylinders, 3 x 6-inch, were prepared using each variation of moisture content. Three PC cylinders each were tested in compression and splitting tension. The specimens with the highest moisture content (5.65 percent) were too weak to removed from the molds undamaged. Only three specimens could be removed from the molds at a moisture content of 1.64 percent (Figure 16). It

seemed as moisture content increased the specimens bonded to the steel molds even though the molds were well coated with the most effective mold release agent tested.

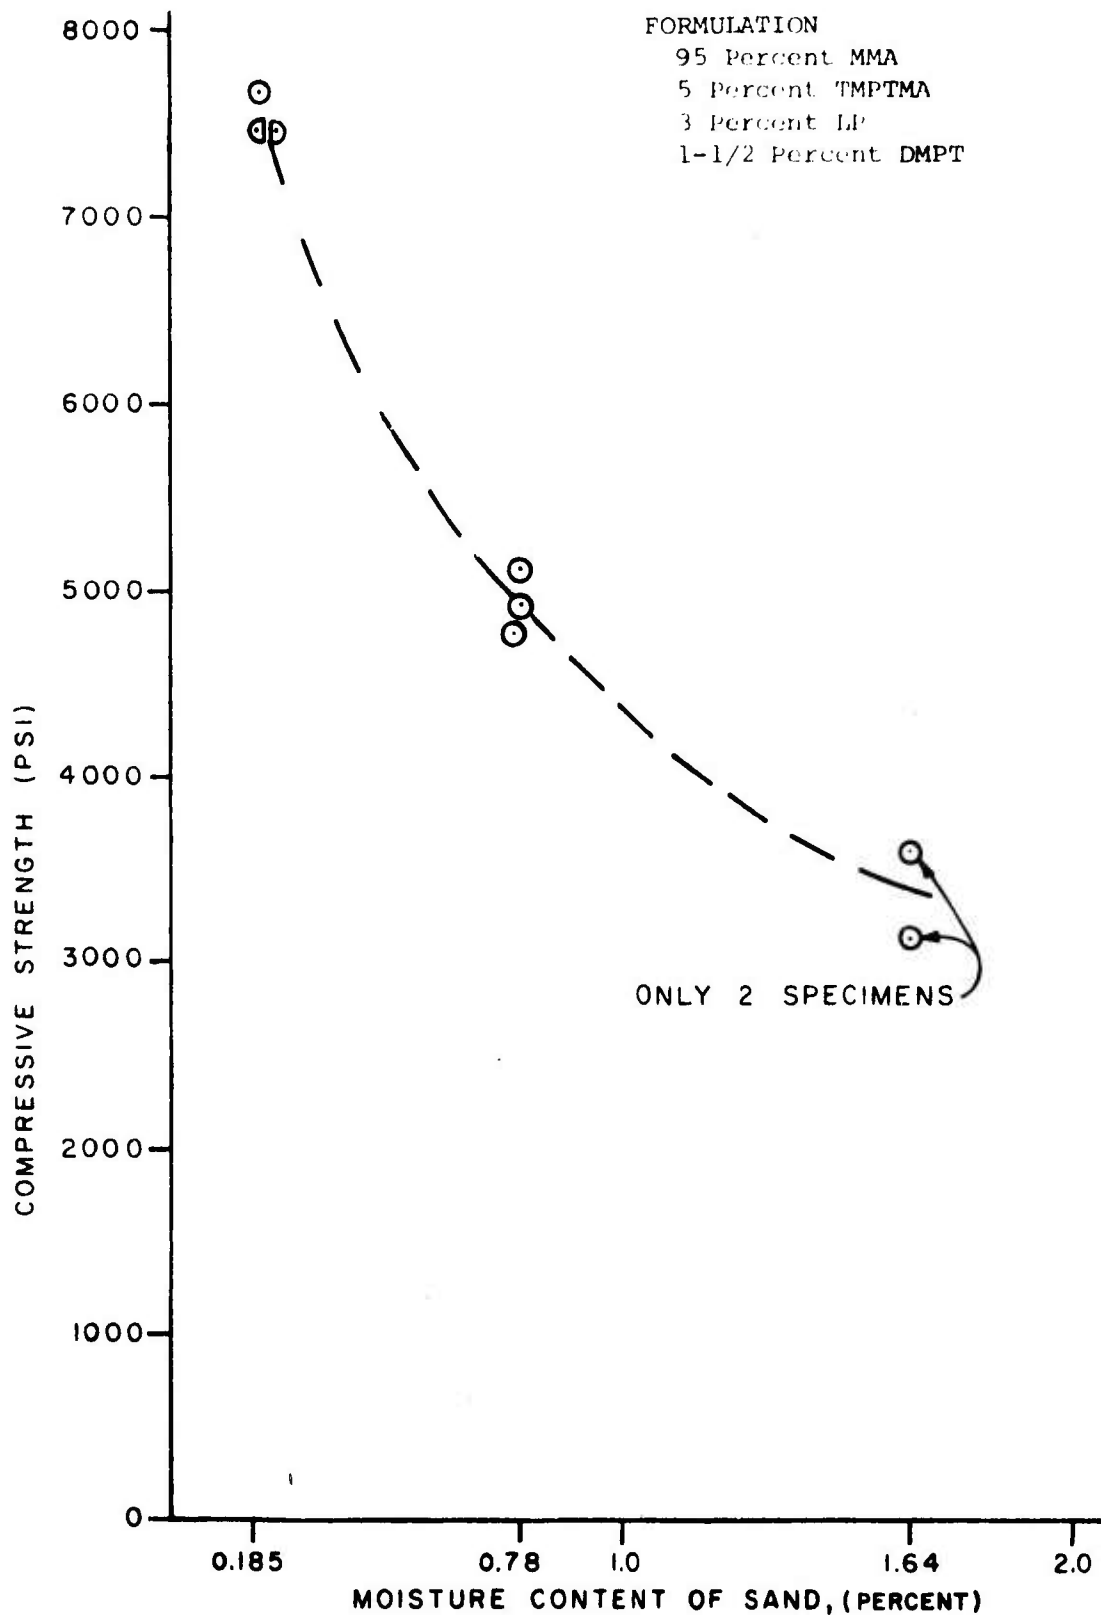
Figure 17. Effect of Moisture Content of Sand on Compressive Strength

Results of the test show that relatively small amounts of moisture reduce the compressive and tensile strengths by as much as 40 percent (Figure 17 and 18). At a moisture content of 0.78 percent the sand was noticeably wet yet good strengths were obtained. This indicates that if the sand can be dried until it has the appearance of dry sand, the moisture content will be low enough to produce good results. The driest sand used (0.185 percent moisture content) had been oven-dried approximately one month earlier and stored in an air conditioned laboratory.

How dry the aggregate must be to use for PC repairs depends on each individual circumstance. Obviously, the economical balance between oven-drying the sand and using a slightly wetter sand with a decreased PC strength depends on the strength required. In most cases, it would be preferable to use the driest sand available. However, in actual practice the sand used by construction crews may not be completely dry and could result in decreased strength.

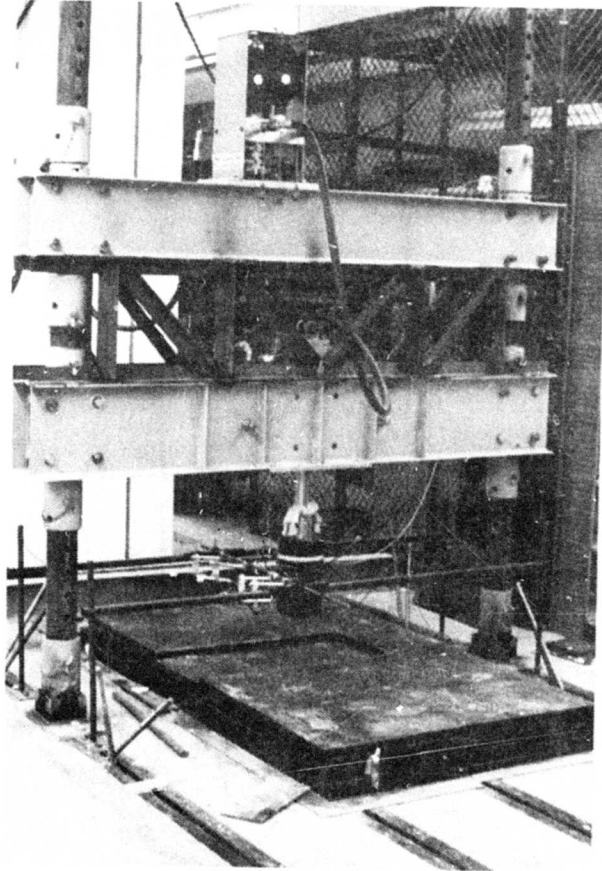
Figure 21. Loading Frame After Reinforcing

The loading frame and loading device were the same as those used in the previous experiments (Figure 21). The load was applied by a hydraulically-driven piston connected to a load cell. The load cell was wired to the MTS loading machine which permitted the precise application of the desired load at 5 cycles per second in the form of a sine wave.

(Note void in rubber subgrade)

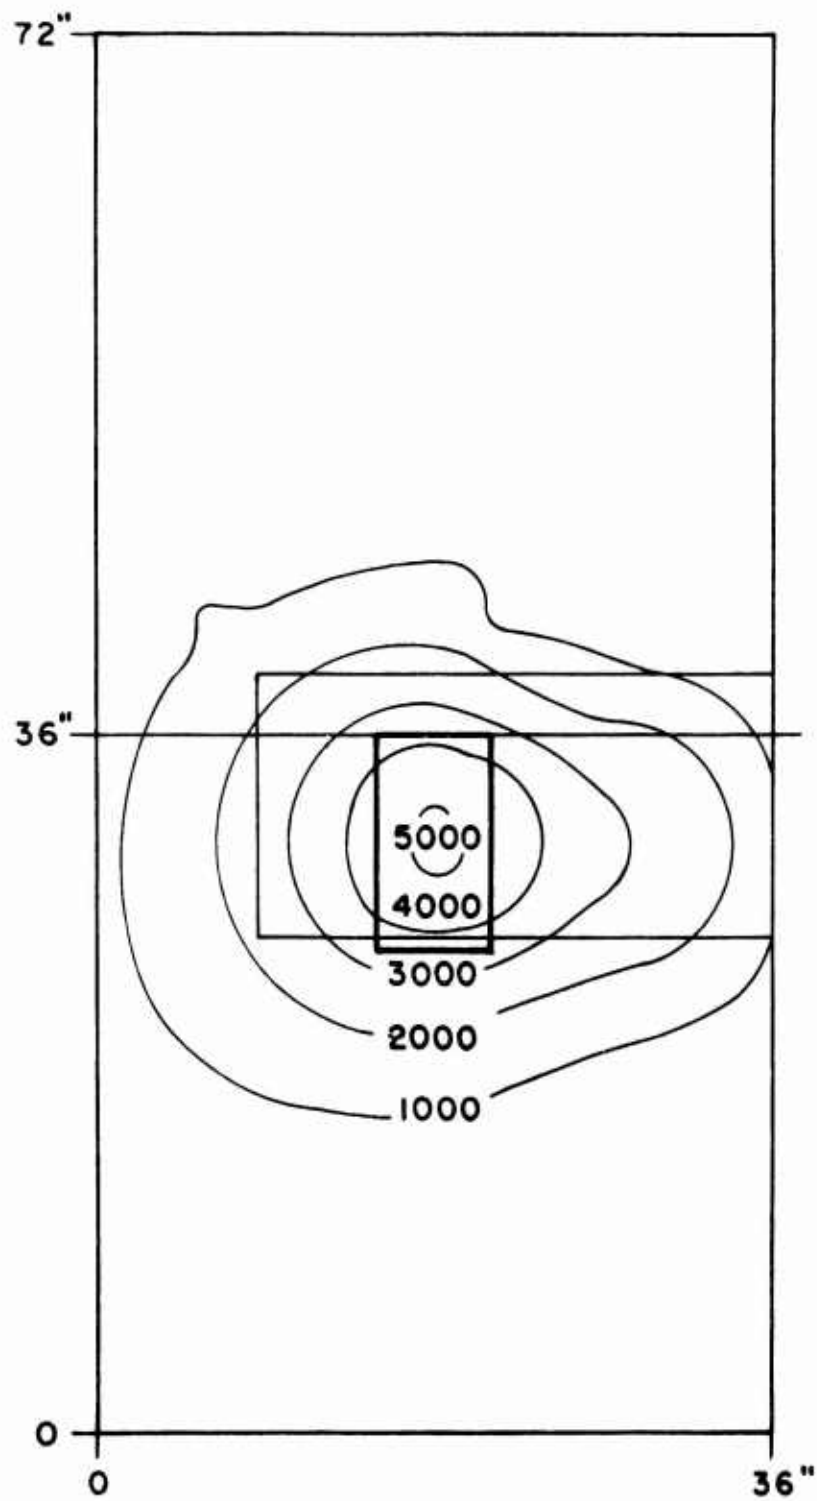
Figure 35. Tensile Stress Contours on the Bottom of Slab 2: 21 Kip Load

The 5000 psi tensile stress in the bottom of Slab 2 (Figure 35) predicted by the computer program was verified using the Westergaard corner equation on a uniform support. It seems inconsistent that the PC slab could withstand a 5000 psi tensile stress when the modulus of rupture was found to be 1500 psi from beam tests (Table 12).

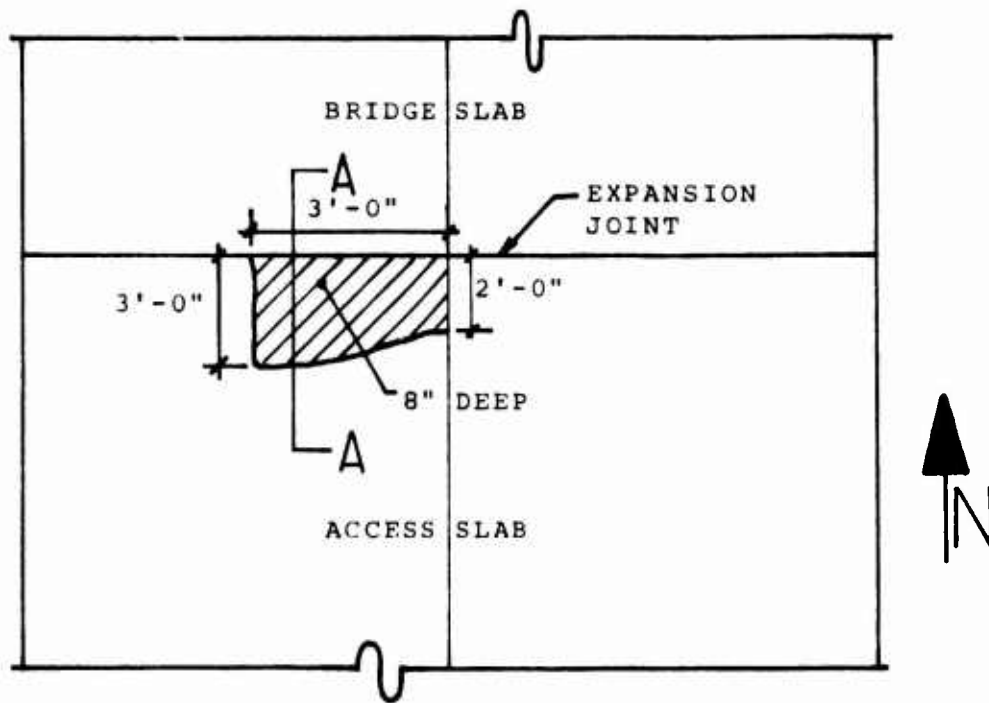
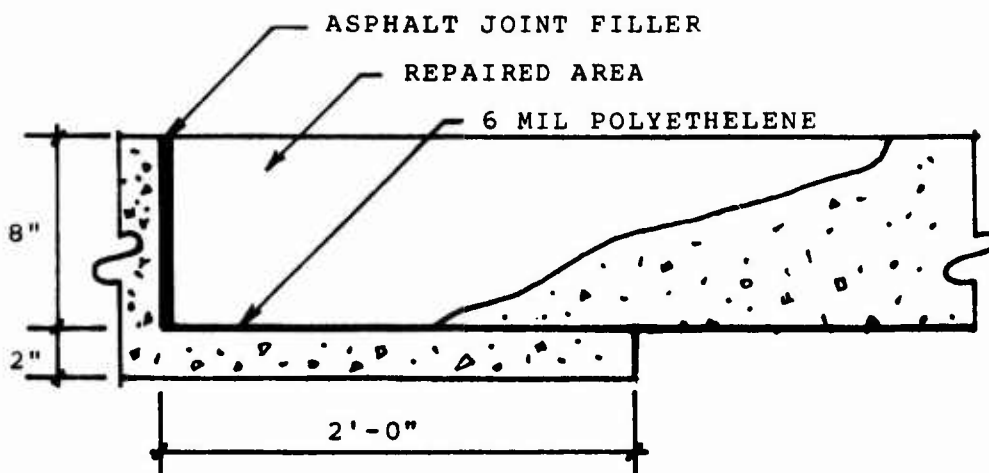
Figure 38. Repair Area 1 on Interstate Highway 35

Area 1. The repair measured 66 x 30 inches by 8 inches deep and was bounded by an expansion joint to the north side. Unsound concrete and asphalt joint filler were removed with an air hammer, and loose debris was cleaned out with compressed air (Figure 40). The concrete was then dried with a portable butane heater to remove possible moisture due to the rain which had fallen the previous day. The bottom of the repair was coated with polyester putty to preserve the expansion joint. Polyester putty was also applied to the vertical face of the adjoining slab, and a 1 x 8-inch board was placed vertically to maintain the expansion joint. A sand and gravel mixture of dried aggregate (40:60 ratio by weight) was placed in the void and screeded to grade. The aggregate was then saturated with the monomer system and finished with concrete trowels at 11:00 AM (Figure 41). There was some leakage at

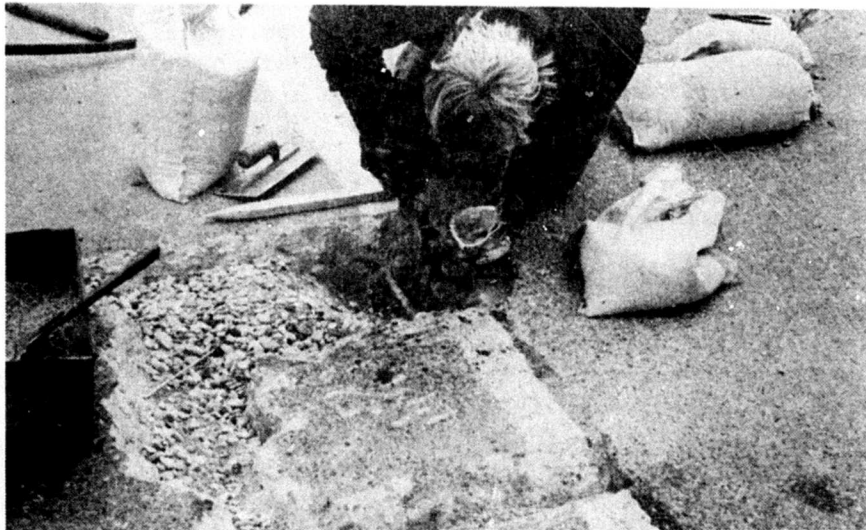
Figure 41. Repair Area 3 Interstate Highway 35

the expansion joint and some runoff due to the slope of the repair which necessitated periodic monomer replenishment. The repair was covered with polyethylene to prevent monomer evaporation. Because of the low ambient temperature and leakage of monomer, the repair did not polymerize until 1:20 PM and was opened to traffic at 2:00 PM. A total of 60 liters of monomer was used to complete the repair.

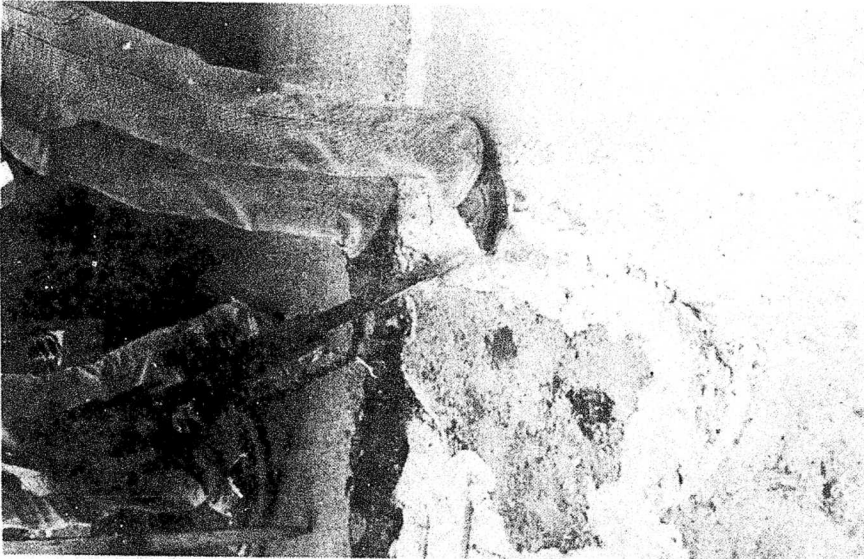
Figure 44. Concrete Preparation

1. Unsound concrete was removed with an air hammer at least to the depth of steel, then loose debris was removed with compressed air (Figure 44).
2. The repair was sealed with polyester putty to seal cracks or protect asphalt shoulder (Figure 45).
3. The repair was filled with a sand and gravel mixture of dried aggregate (40:60 ratio by weight) (Figure 46).
4. Monomer was added to saturate the aggregate (Table 16) (Figure 47).
5. The PC was vibrated to remove entrapped air (Figure 48).
6. The surface was finished by screeding and then troweling to achieve the desired texture.
7. The repair was covered with polyethylene to prevent evaporation of monomer.

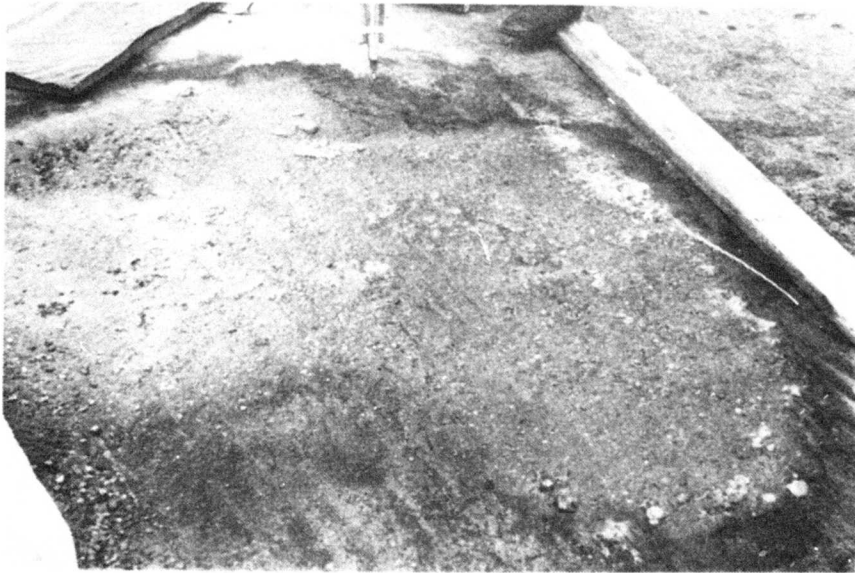
Figure 50. Blistering of Area 1

All repairs polymerized in less than 1 hour and were structurally sound. The surface of Repair Area 1 exhibited surface blisters which were theorized to be caused by expanding air from the exotherm reaction being trapped below the semi-hard surface of PC (Figure 50). The effect is only cosmetic and the "blistered" skin is quickly worn away by traffic. The reason for a preliminary surface hardening was the high ambient temperature and rapid cure time. The surface of Area 5 which was screeded rather than troweled contained less blistering of PC. The blistering was absent in Repair Areas 2, 3, and 4 which suggested that blistering was more of a problem in the deeper repairs (Figure 51). Both Areas 1 and 5 indicated a slight volumetric expansion resulting in the surface being 1/8 to 1/4 inch above concrete grade.

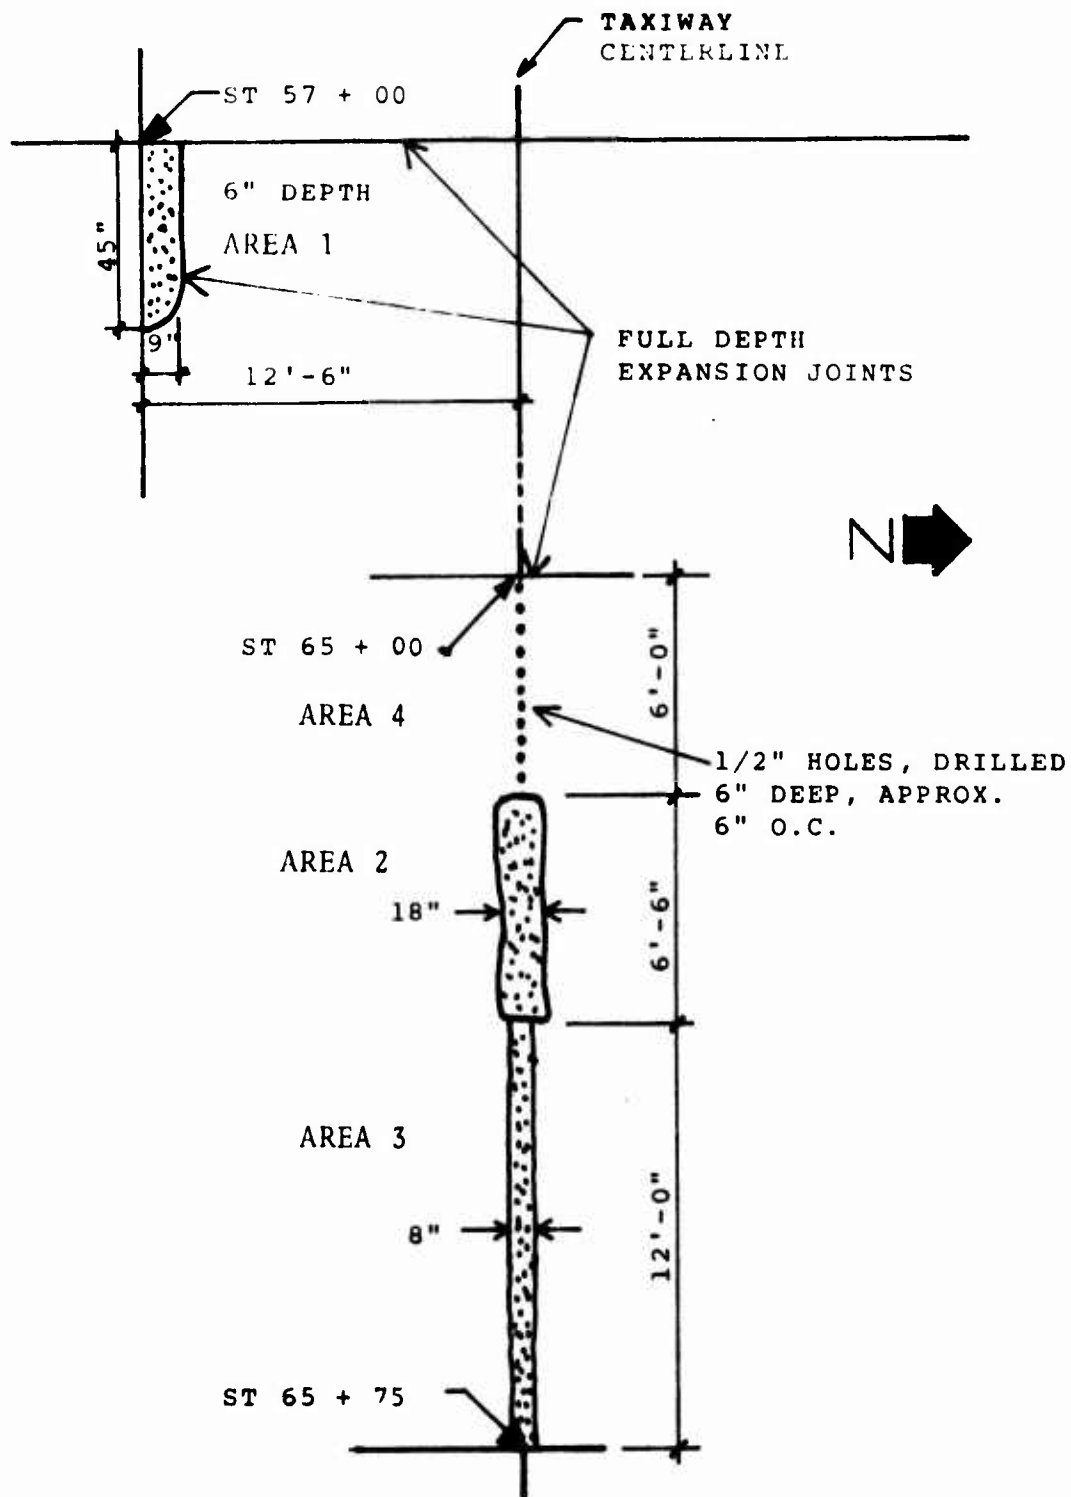
Figure 52. Repair Locations at Houston Intercontinental Airport

Area 1. The first repair was located at station 57 + 00 to 57 + 04, 12.5 feet south of the centerline (Figure 52). The repair measured 45 x 9 inches with depths varying up to 6 inches and was bounded by two expansion joints (Figure 53). A temporary asphalt repair was removed with an air hammer (Figure 54) and sandblasting (Figure 55). The repair was then cleaned of loose debris with compressed air. The removal of all asphalt was deemed necessary because asphalt tends to retard the curing of the monomer system. Wood strips were fitted along the two edges to maintain the expansion joints. An approximate 50:50 mixture by weight of oven-dried 3/8-inch topping rock and sandblasting was placed in the repair and leveled to grade. The monomer system (Table 17) was added until the aggregate was saturated (Figure 56). The repair was troweled with concrete trowels to produce a smooth finish (Figure 57). The total repair time of Area 1 was longer than normal because of several equipment breakdowns of the air hammer and sandblasting equipment. The monomer was not added until 12:00 noon, with final polymerization occurring by 1:10 PM (Figure 58). A total of 24,000 cc's of monomer was used to complete the repair, approximately twice the estimated amount because of severe leakage in the expansion joint.
